Subject: Department of Natural Resources Washington Geological Survey,
School Seismic Safety Assessment Project, Contract No. AE 410 -
Seismic Evaluation for **Concrete School District**

School Buildings Evaluated in the Concrete School District

Table 1-3. Identified Structural Seismic Deficiencies for Concrete Concrete High School Main Building

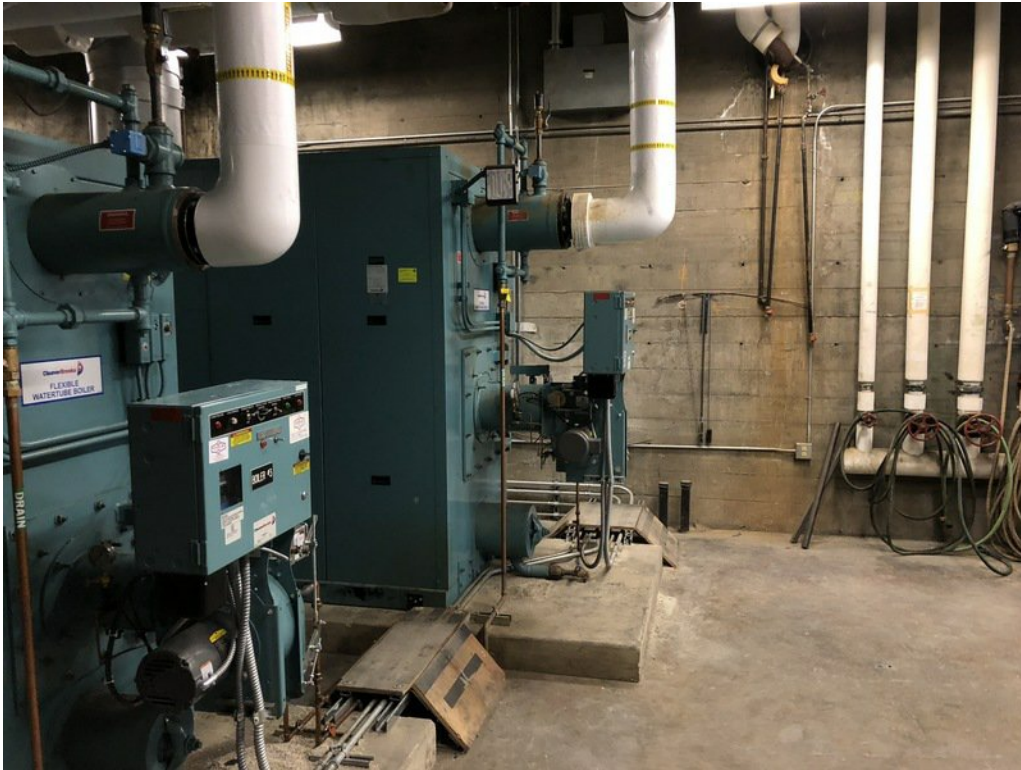
Figure 1-1. Mechanical room interior.

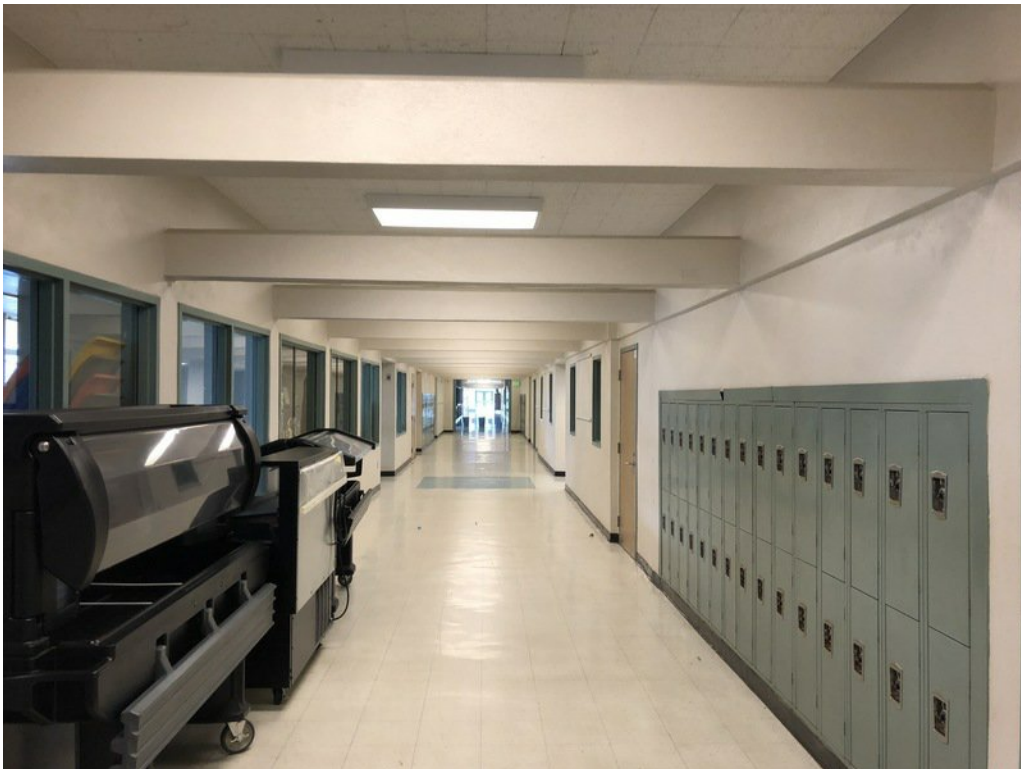
Figure 1-2. Interior corridor with steel beams encased by veneer plaster.

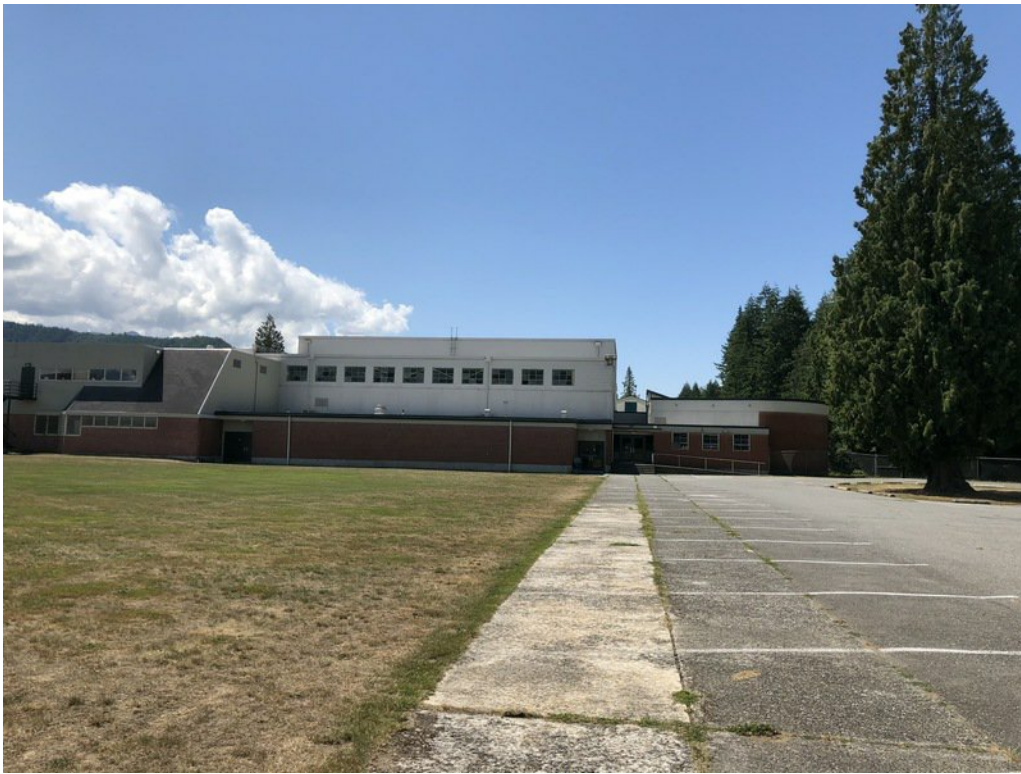
Figure 1-5. Exterior east side of building.

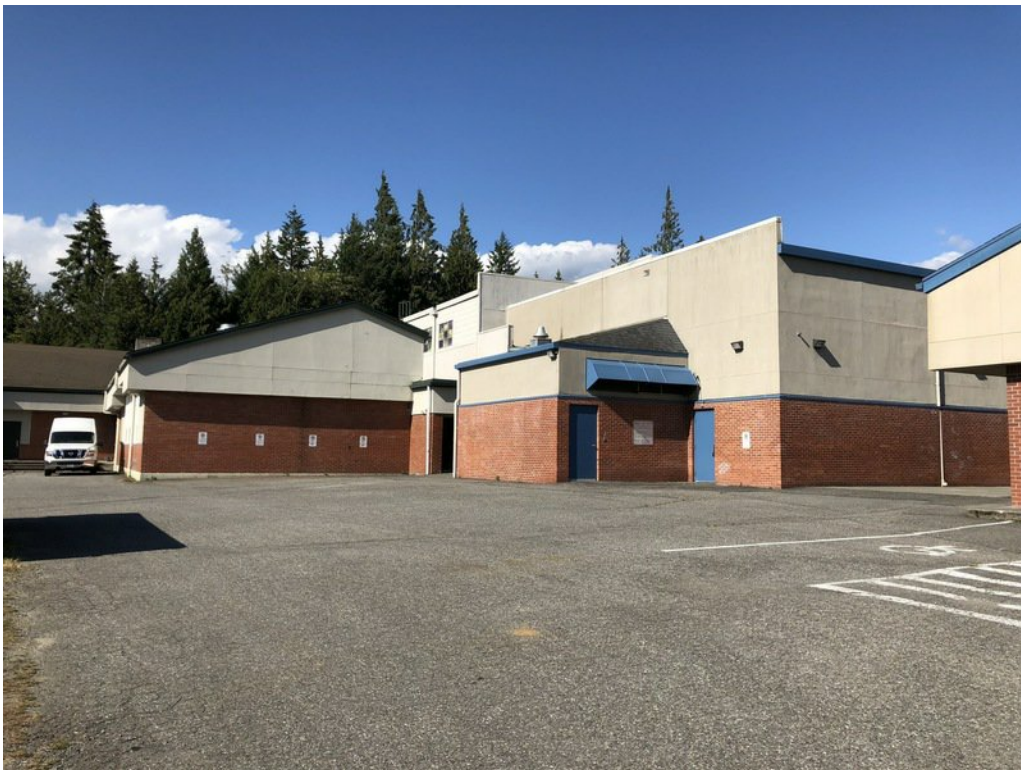
Figure 1-6. Exterior south side of building.

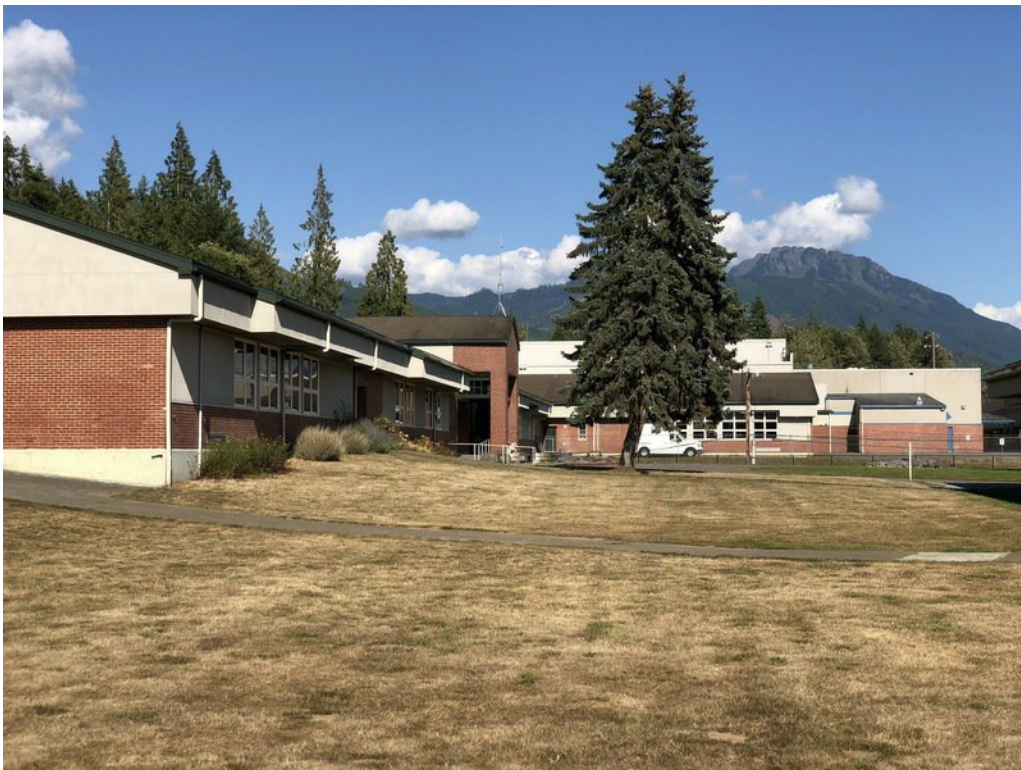
Figure 1-8. Exterior south side of building facing east.

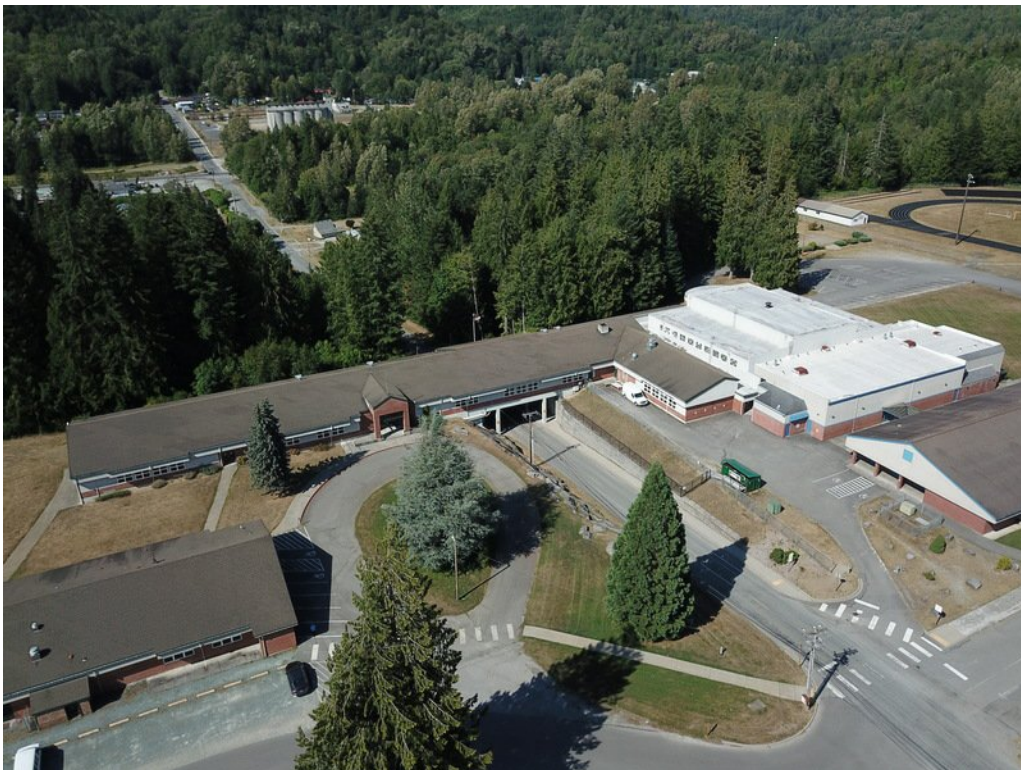
Figure 1-10. Exterior south side of building.

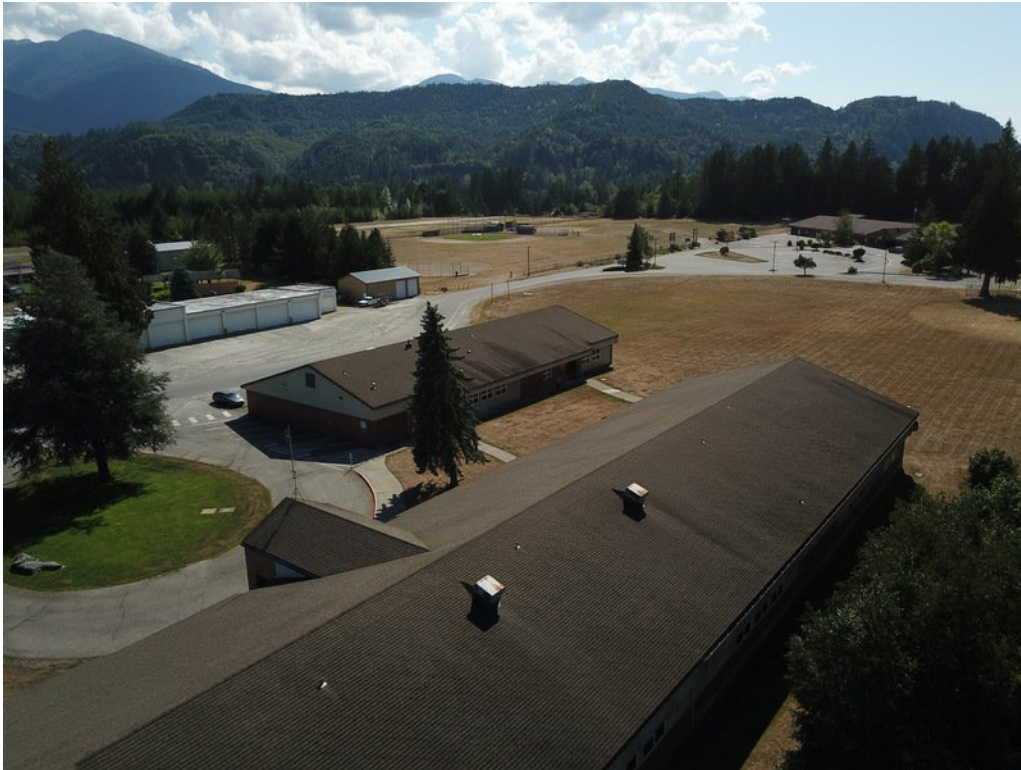
Figure 1-1. Exterior northeast side of tech building (building in middle of the photograph).

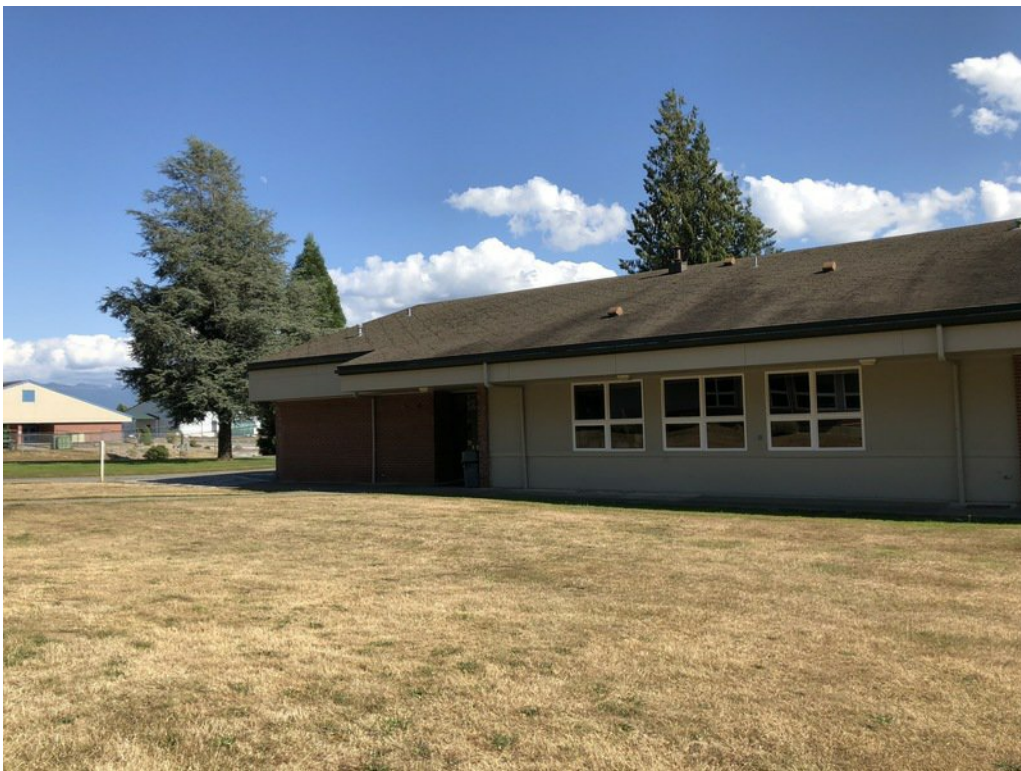
Figure 1-2. Exterior north side of tech building.

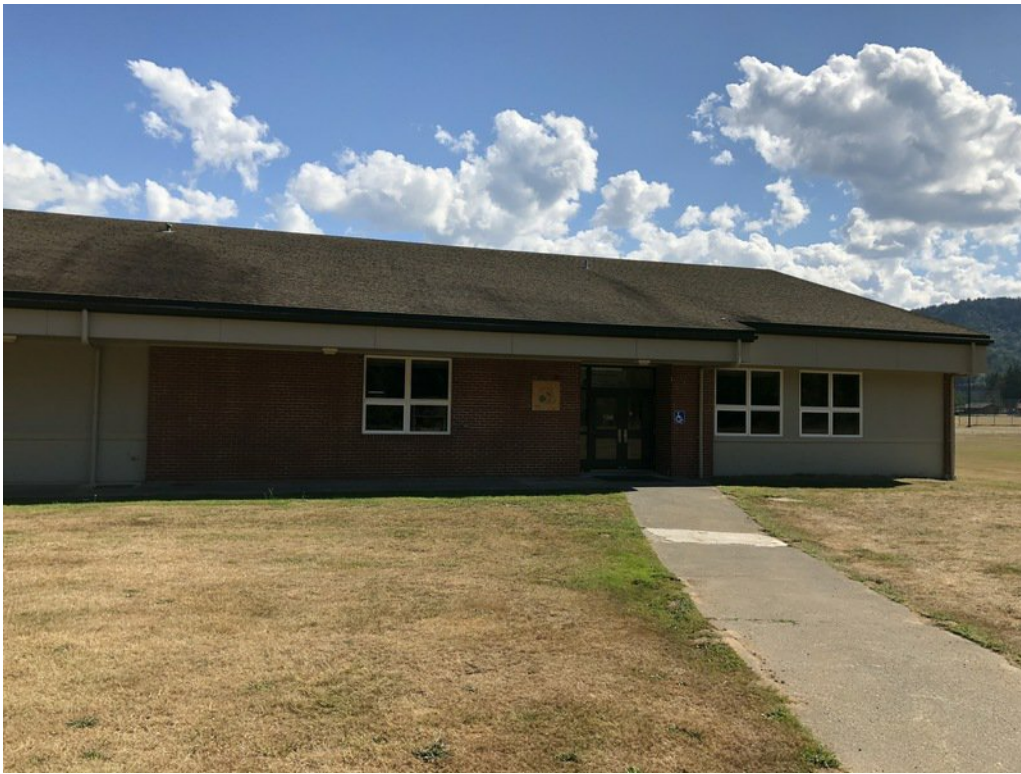
Figure 1-3. Exterior north side of tech building.

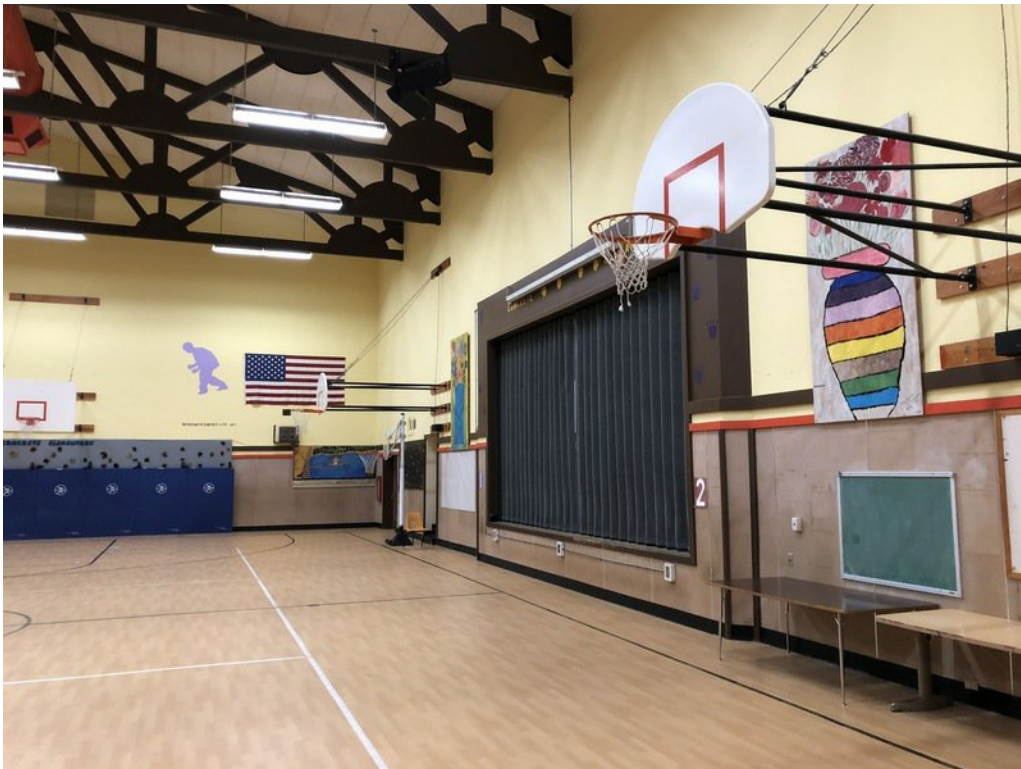
Figure 1-2. Interior of gym.

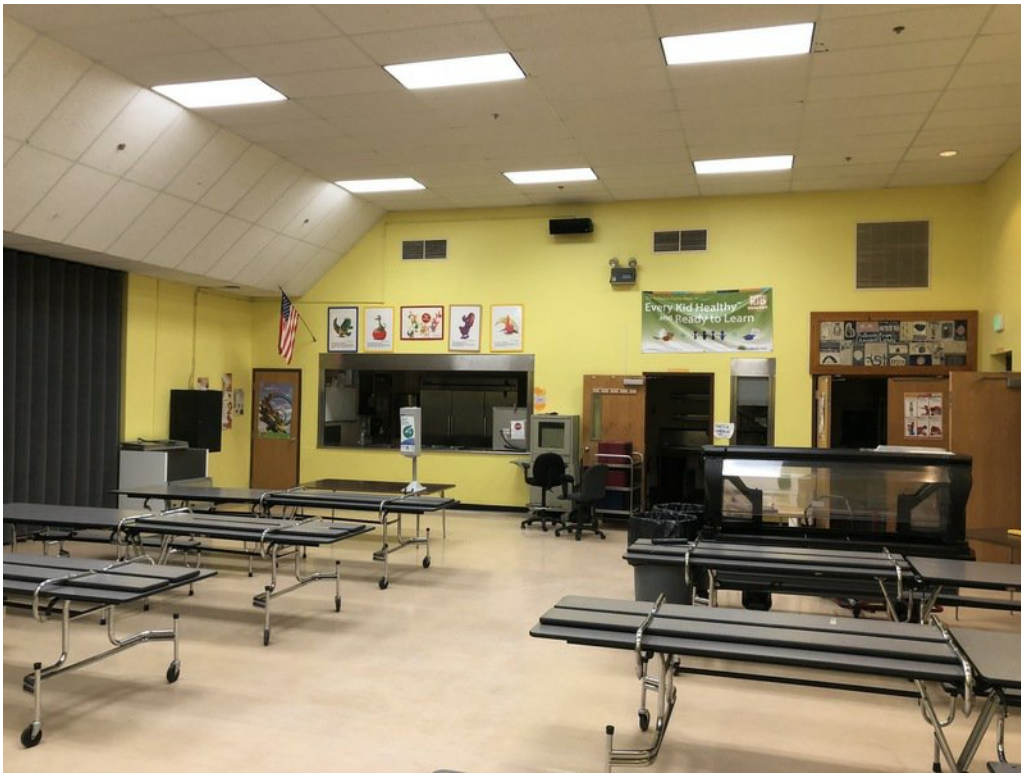
Figure 1-3. Interior of multipurpose room.

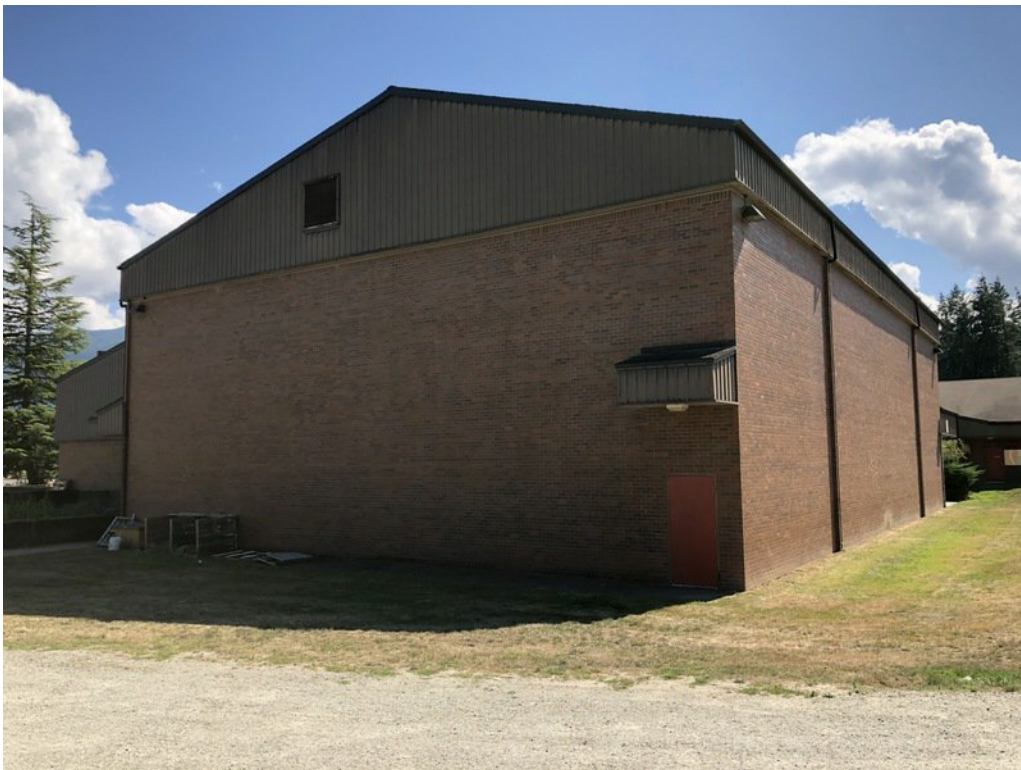
Figure 1-4. Exterior northeast side of gym.

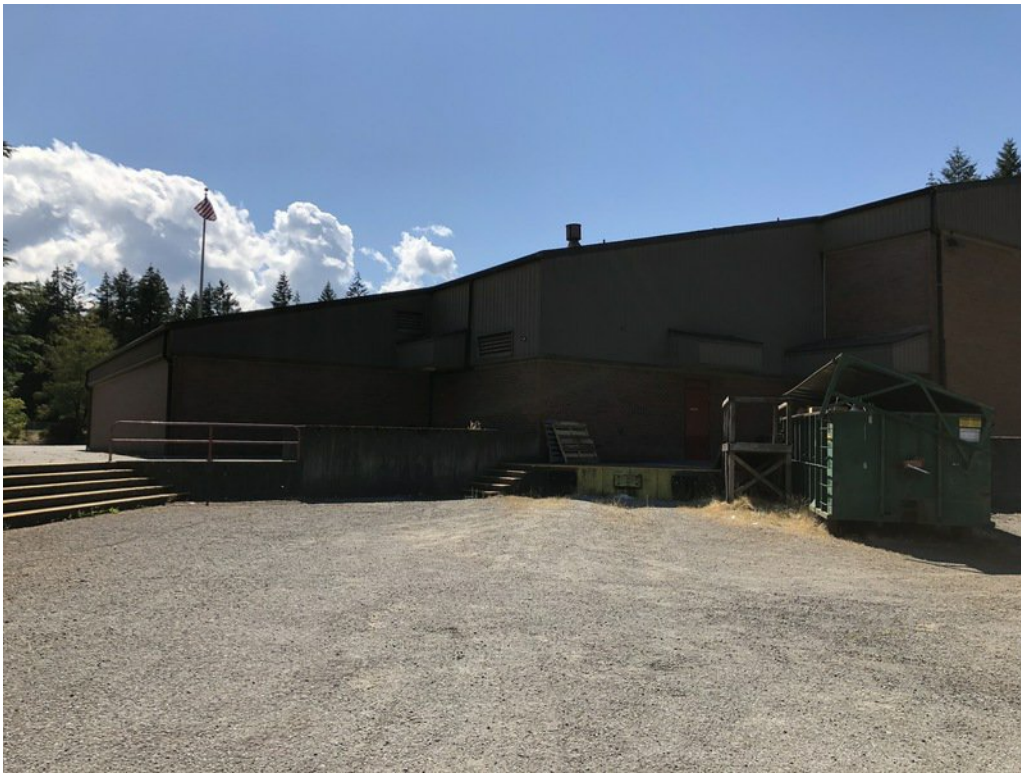
Figure 1-5. Exterior east side of gym.

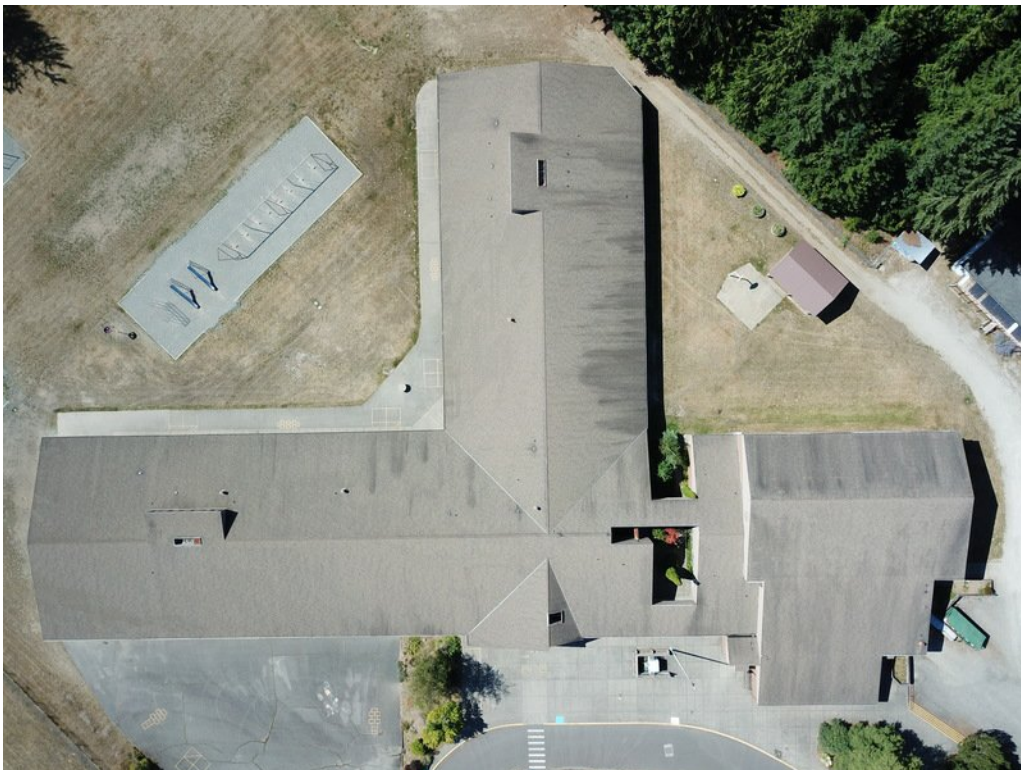
Figure 1-6. Exterior plan of the main building and the gym building.

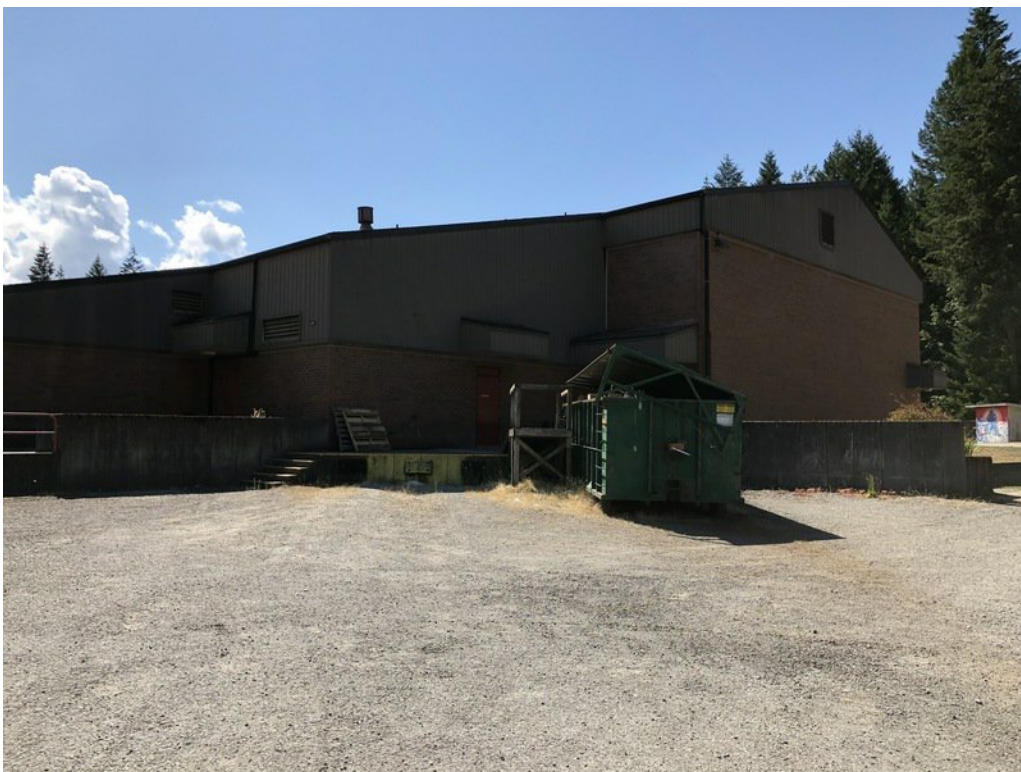
Figure 1-8. Exterior east side of building.

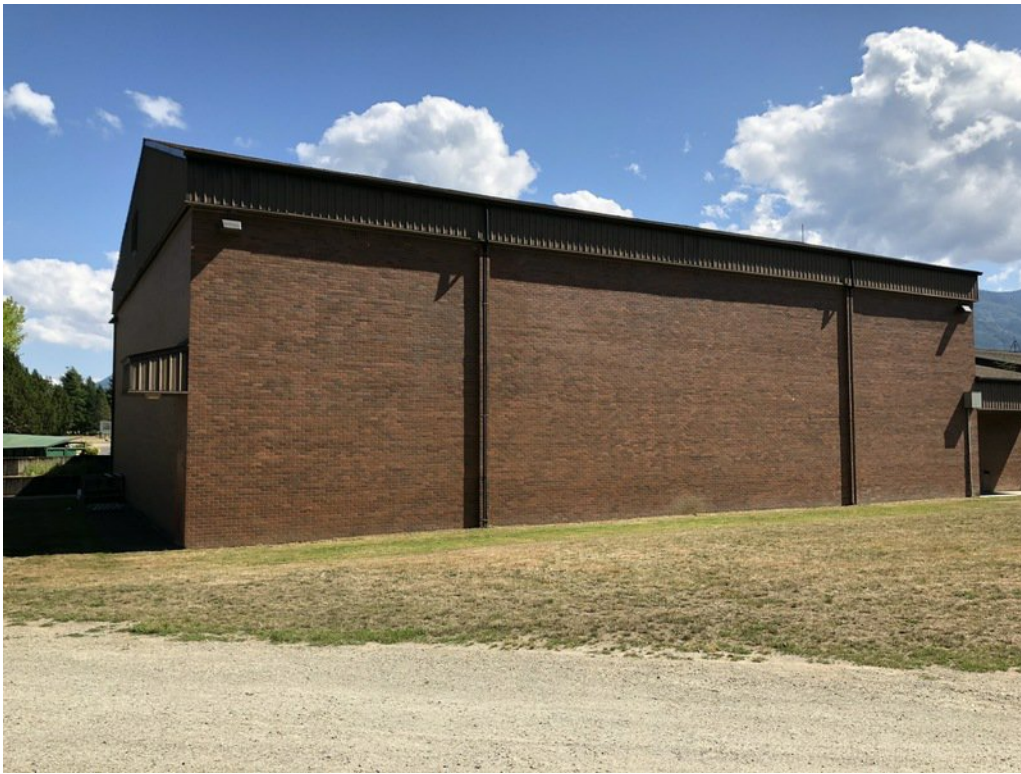
Figure 1-9. Exterior north side of building.

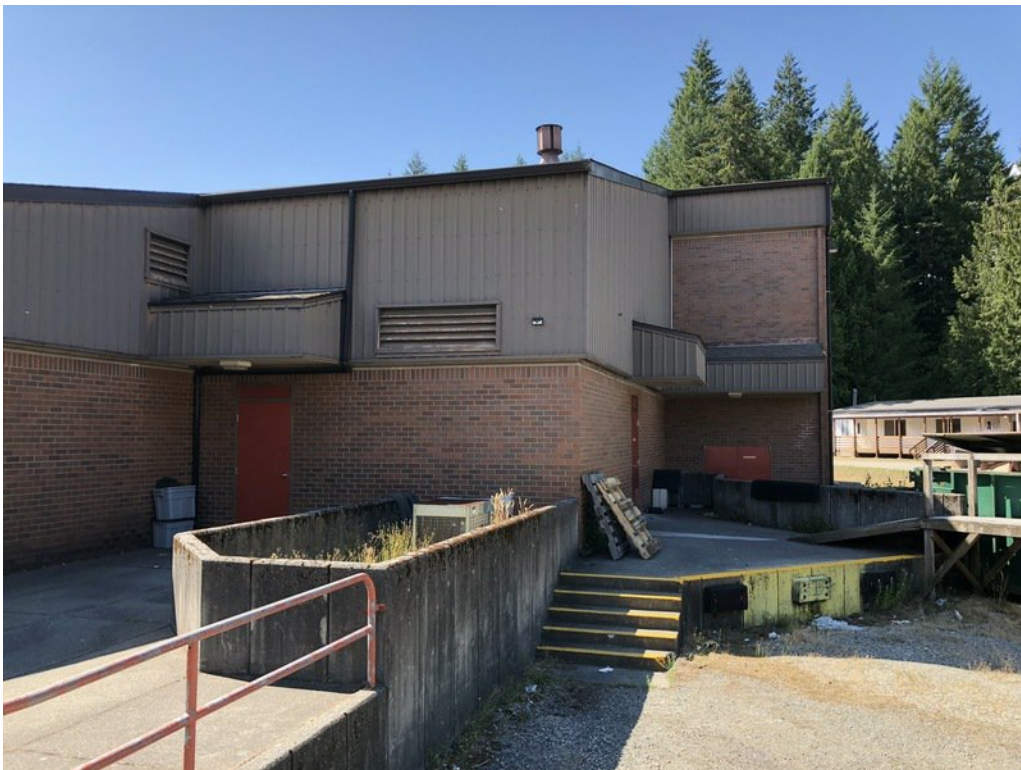
Figure 1-10. Exterior southeast corner of building.

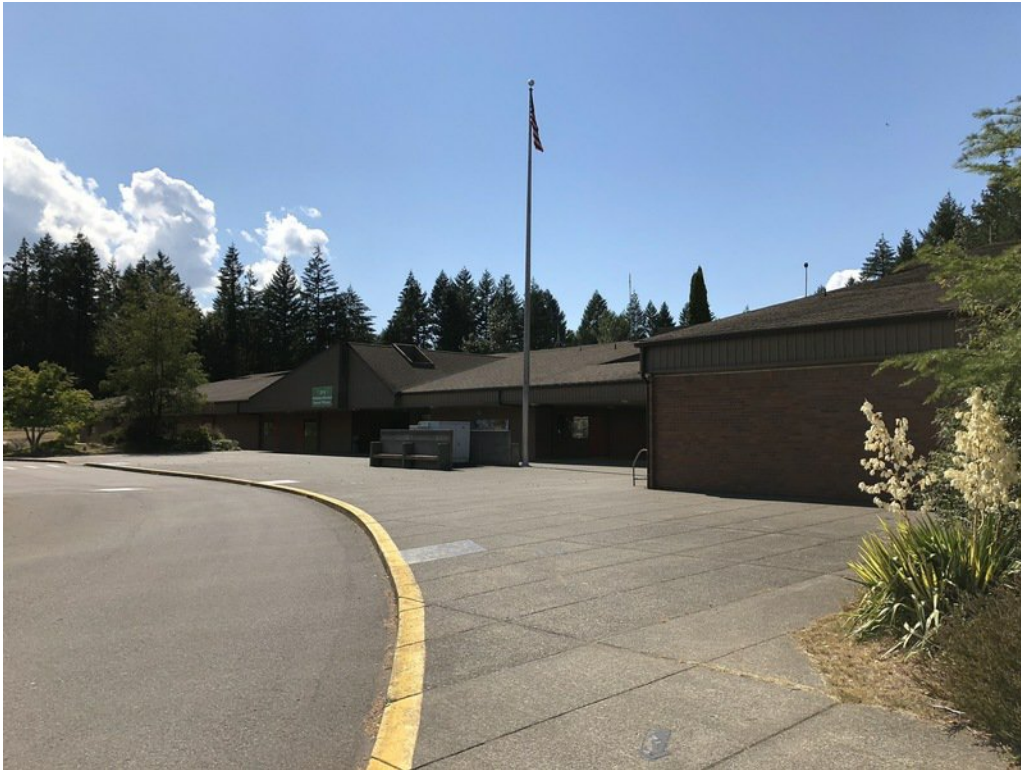
Figure 1-1. Exterior south side of building.

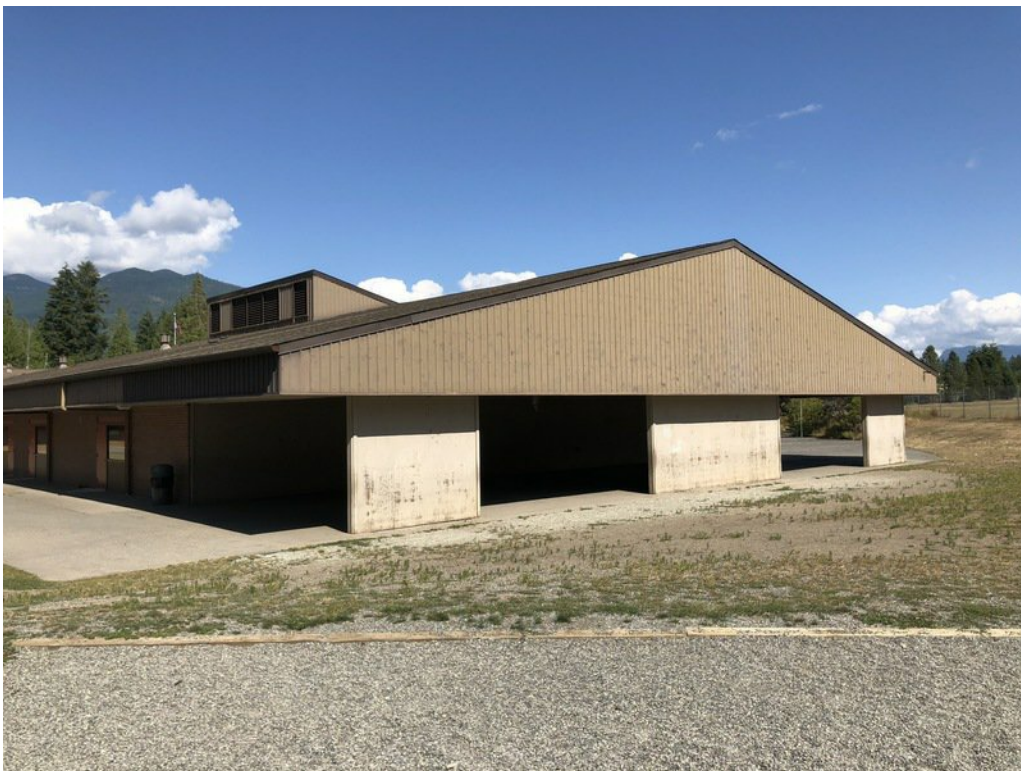
Figure 1-2. Exterior southwest side of building.

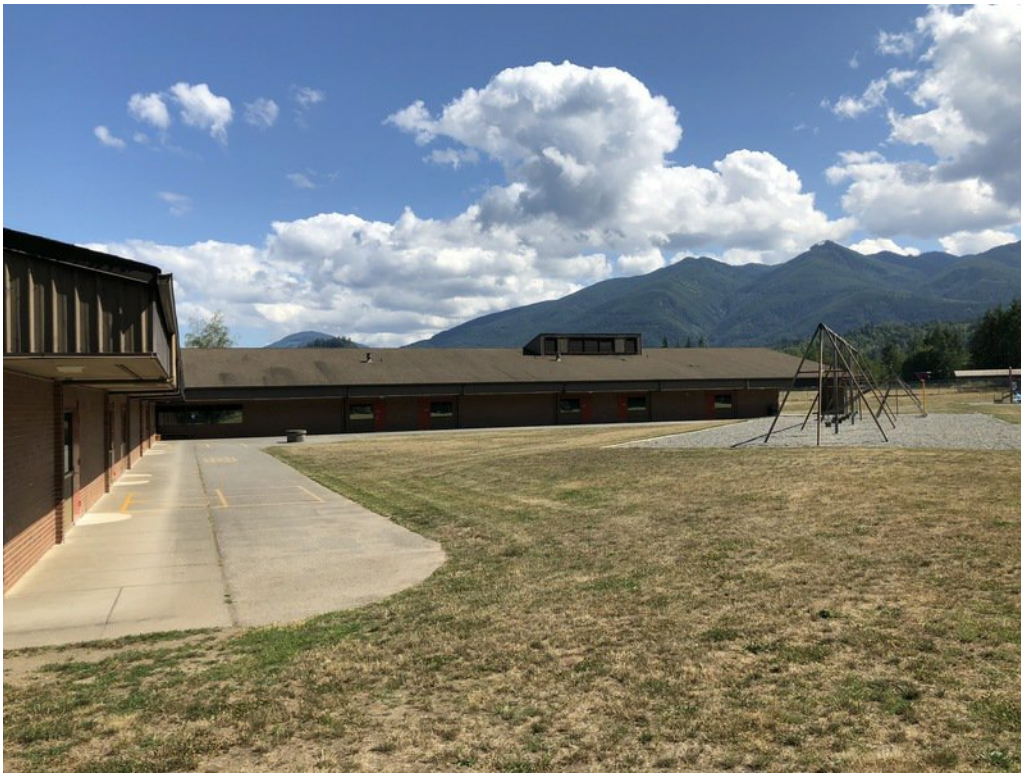
Figure 1-3. Exterior north side of building of the interior angle.

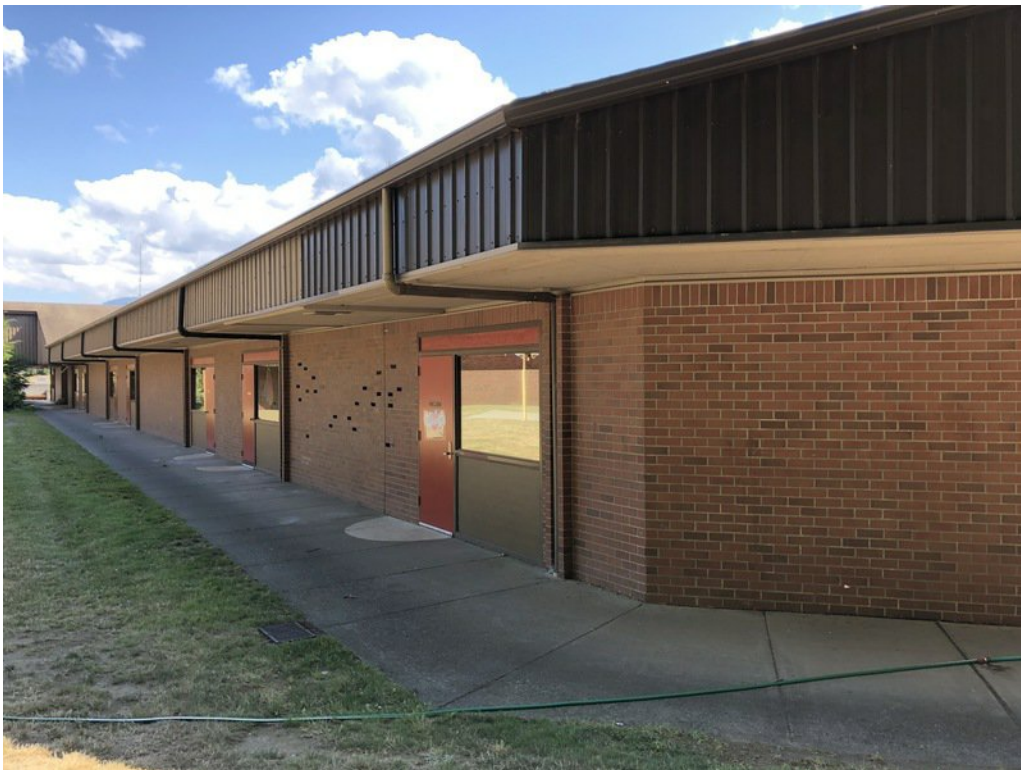
Figure 1-4. Exterior north side of building.

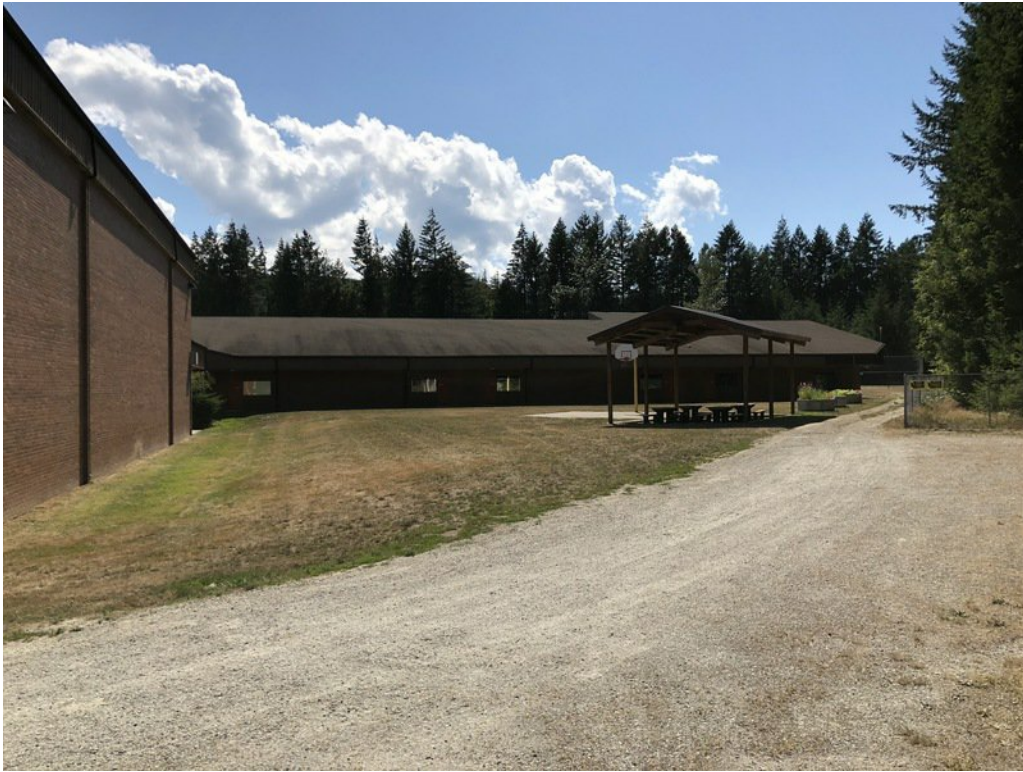
Figure 1-5. Exterior northeast side of building.

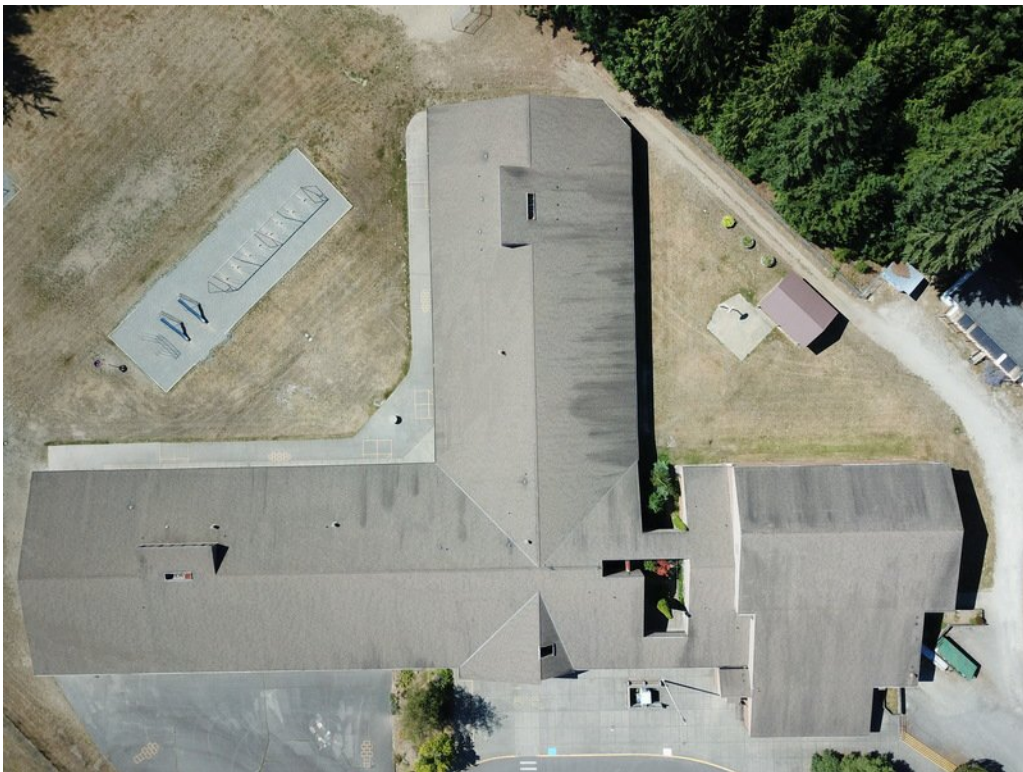
Figure 1-6. Exterior plan of the main building and gym.

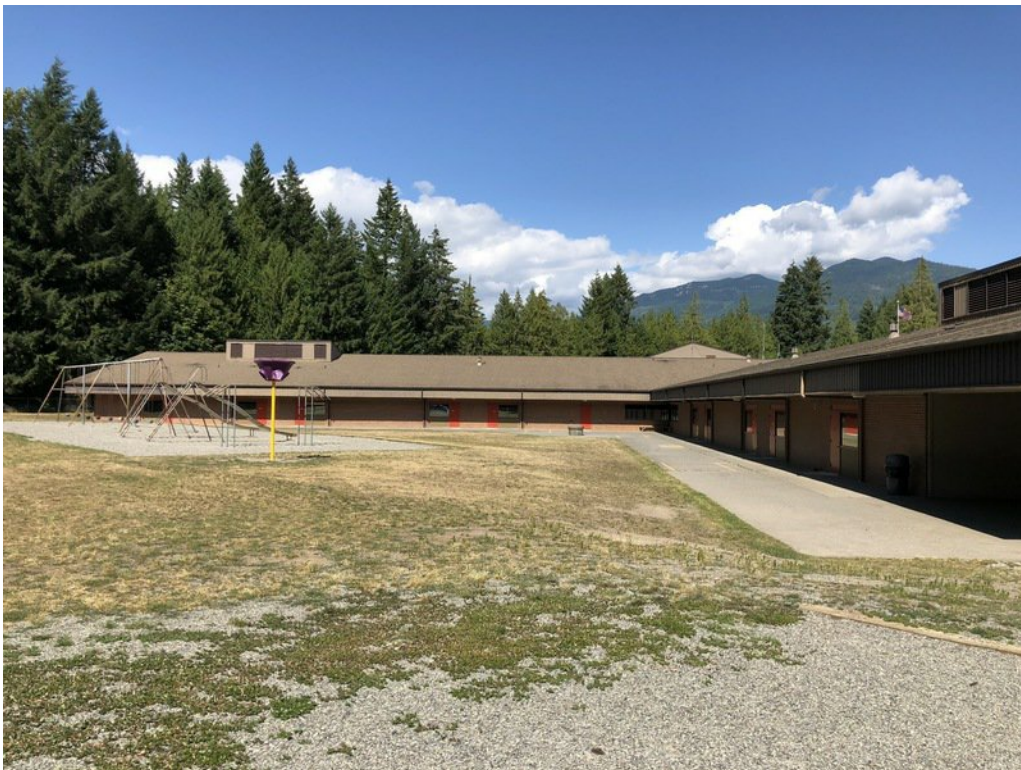
Figure 1-8. Exterior west side of building of the interior angle.
